THERMAL STABILITY TEST :

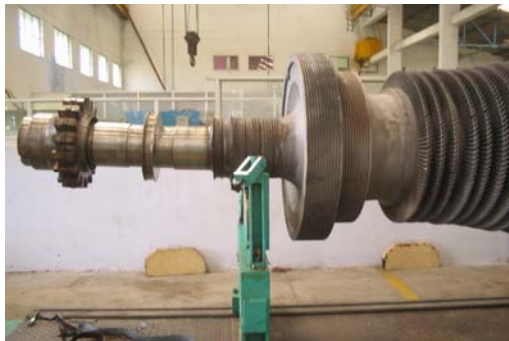
Before bend removal
(103mm bend)

Due to long storage or abnormal changes in operational parameters such as pressure and temperature or abnormal changes in startup or shutdown activities or due to sudden quenching of Rotors due to malfunctioning of drains, the Rotors can get bent.

This results in non- co-axiality of Geometric axis and Mass axis of the Rotor resulting in non uniform stresses and ultimate rejection of Rotors from operation.

Hence it is recommended to remove the bend by stress relieving operation so as to make the geometric and mass axis coaxial.

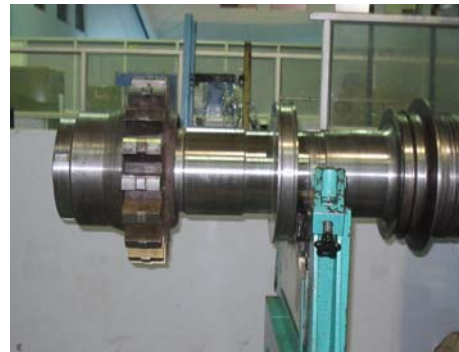
After bend Removal

In our In-House PLC based thermal stability test Facility, with online digital display for monitoring of Run-out measurement as per the latest technology, we undertake removal of bend in the Rotors by predetermined thermal cycles based on Material of construction and size of Rotor by heating, soaking and cooling till the uniform metallurgical transformation is achieved and there by the bend is brought down to the design values.

By this method, all the induced stresses are totally relieved and Mass axis and Geometric axis are made coaxial within limits.

This makes the rotors to operate at original specifications. We have undertaken several Rotor bend removals with bends varying from 0.1 mm up to 104mm. and subsequently all the Rotors are in operation in excellent condition.
